Point Reyes National Seashore
Coastal Watershed Restoration Project

Coastal Watershed Restoration Program –
Geomorphic Restoration Project - Environmental Assessment
Figure 2.4

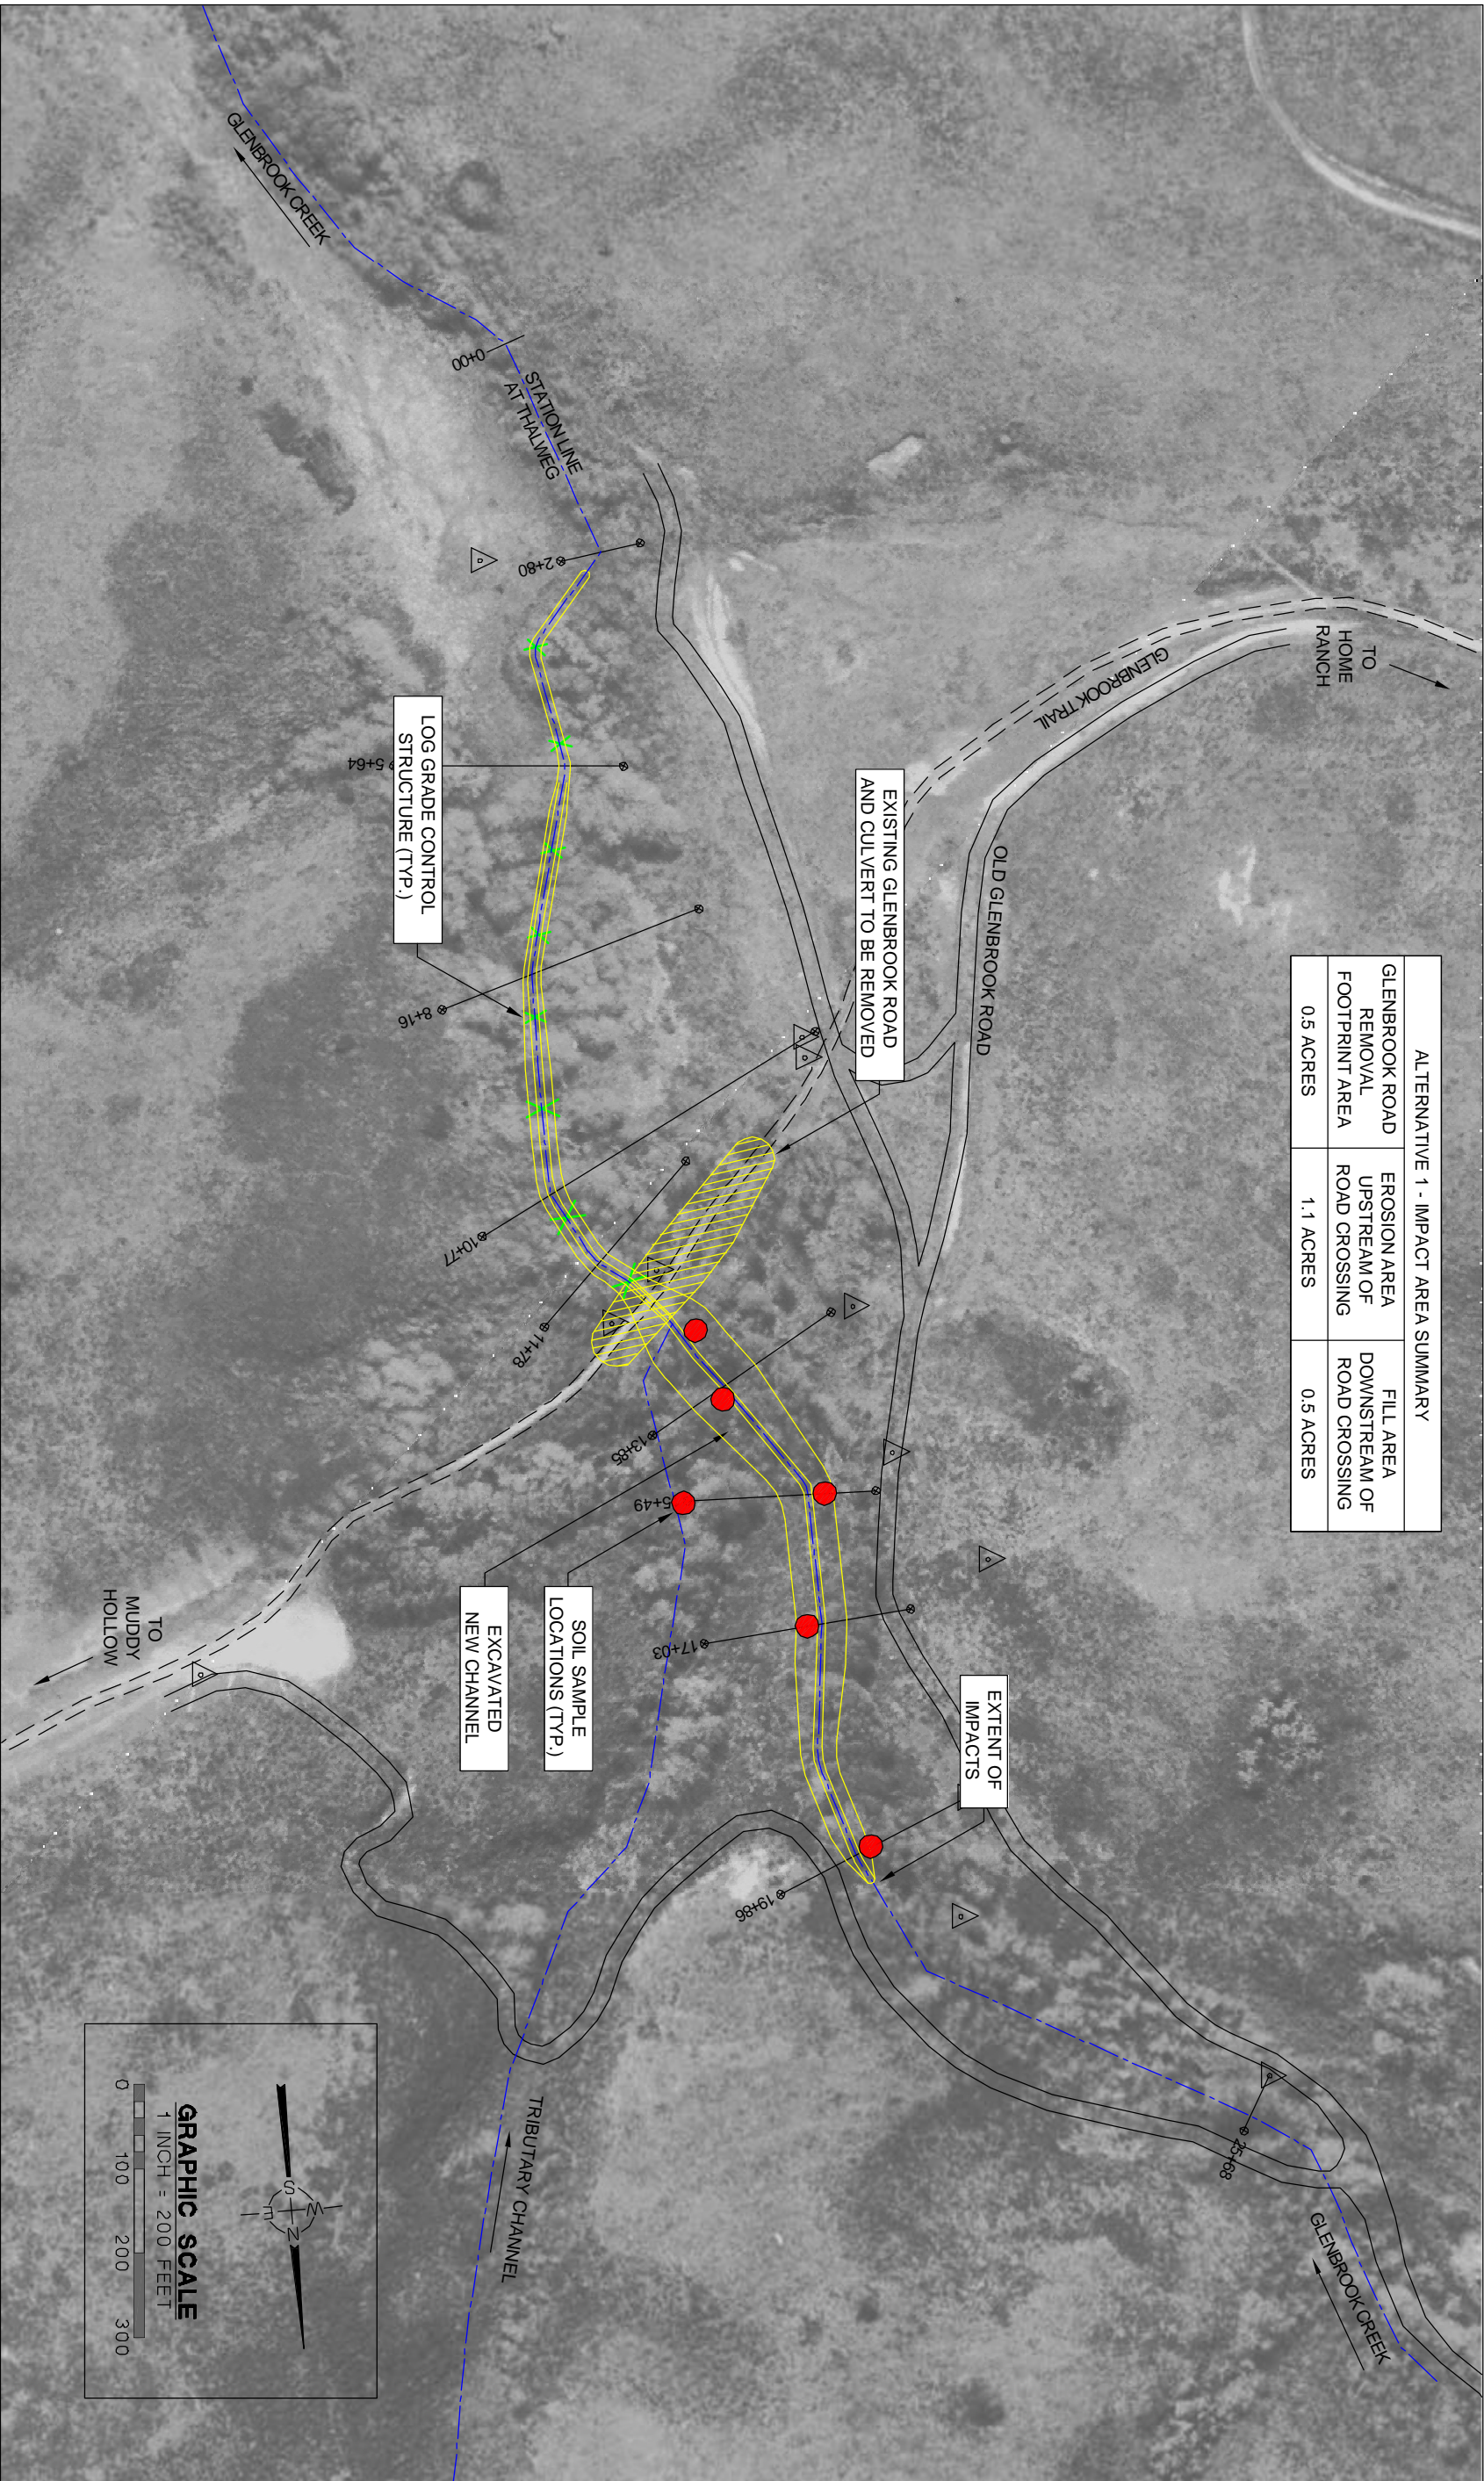
Figure 15. Alternative 1: Glenbrook Crossing Restoration Site Plan - Channel Development

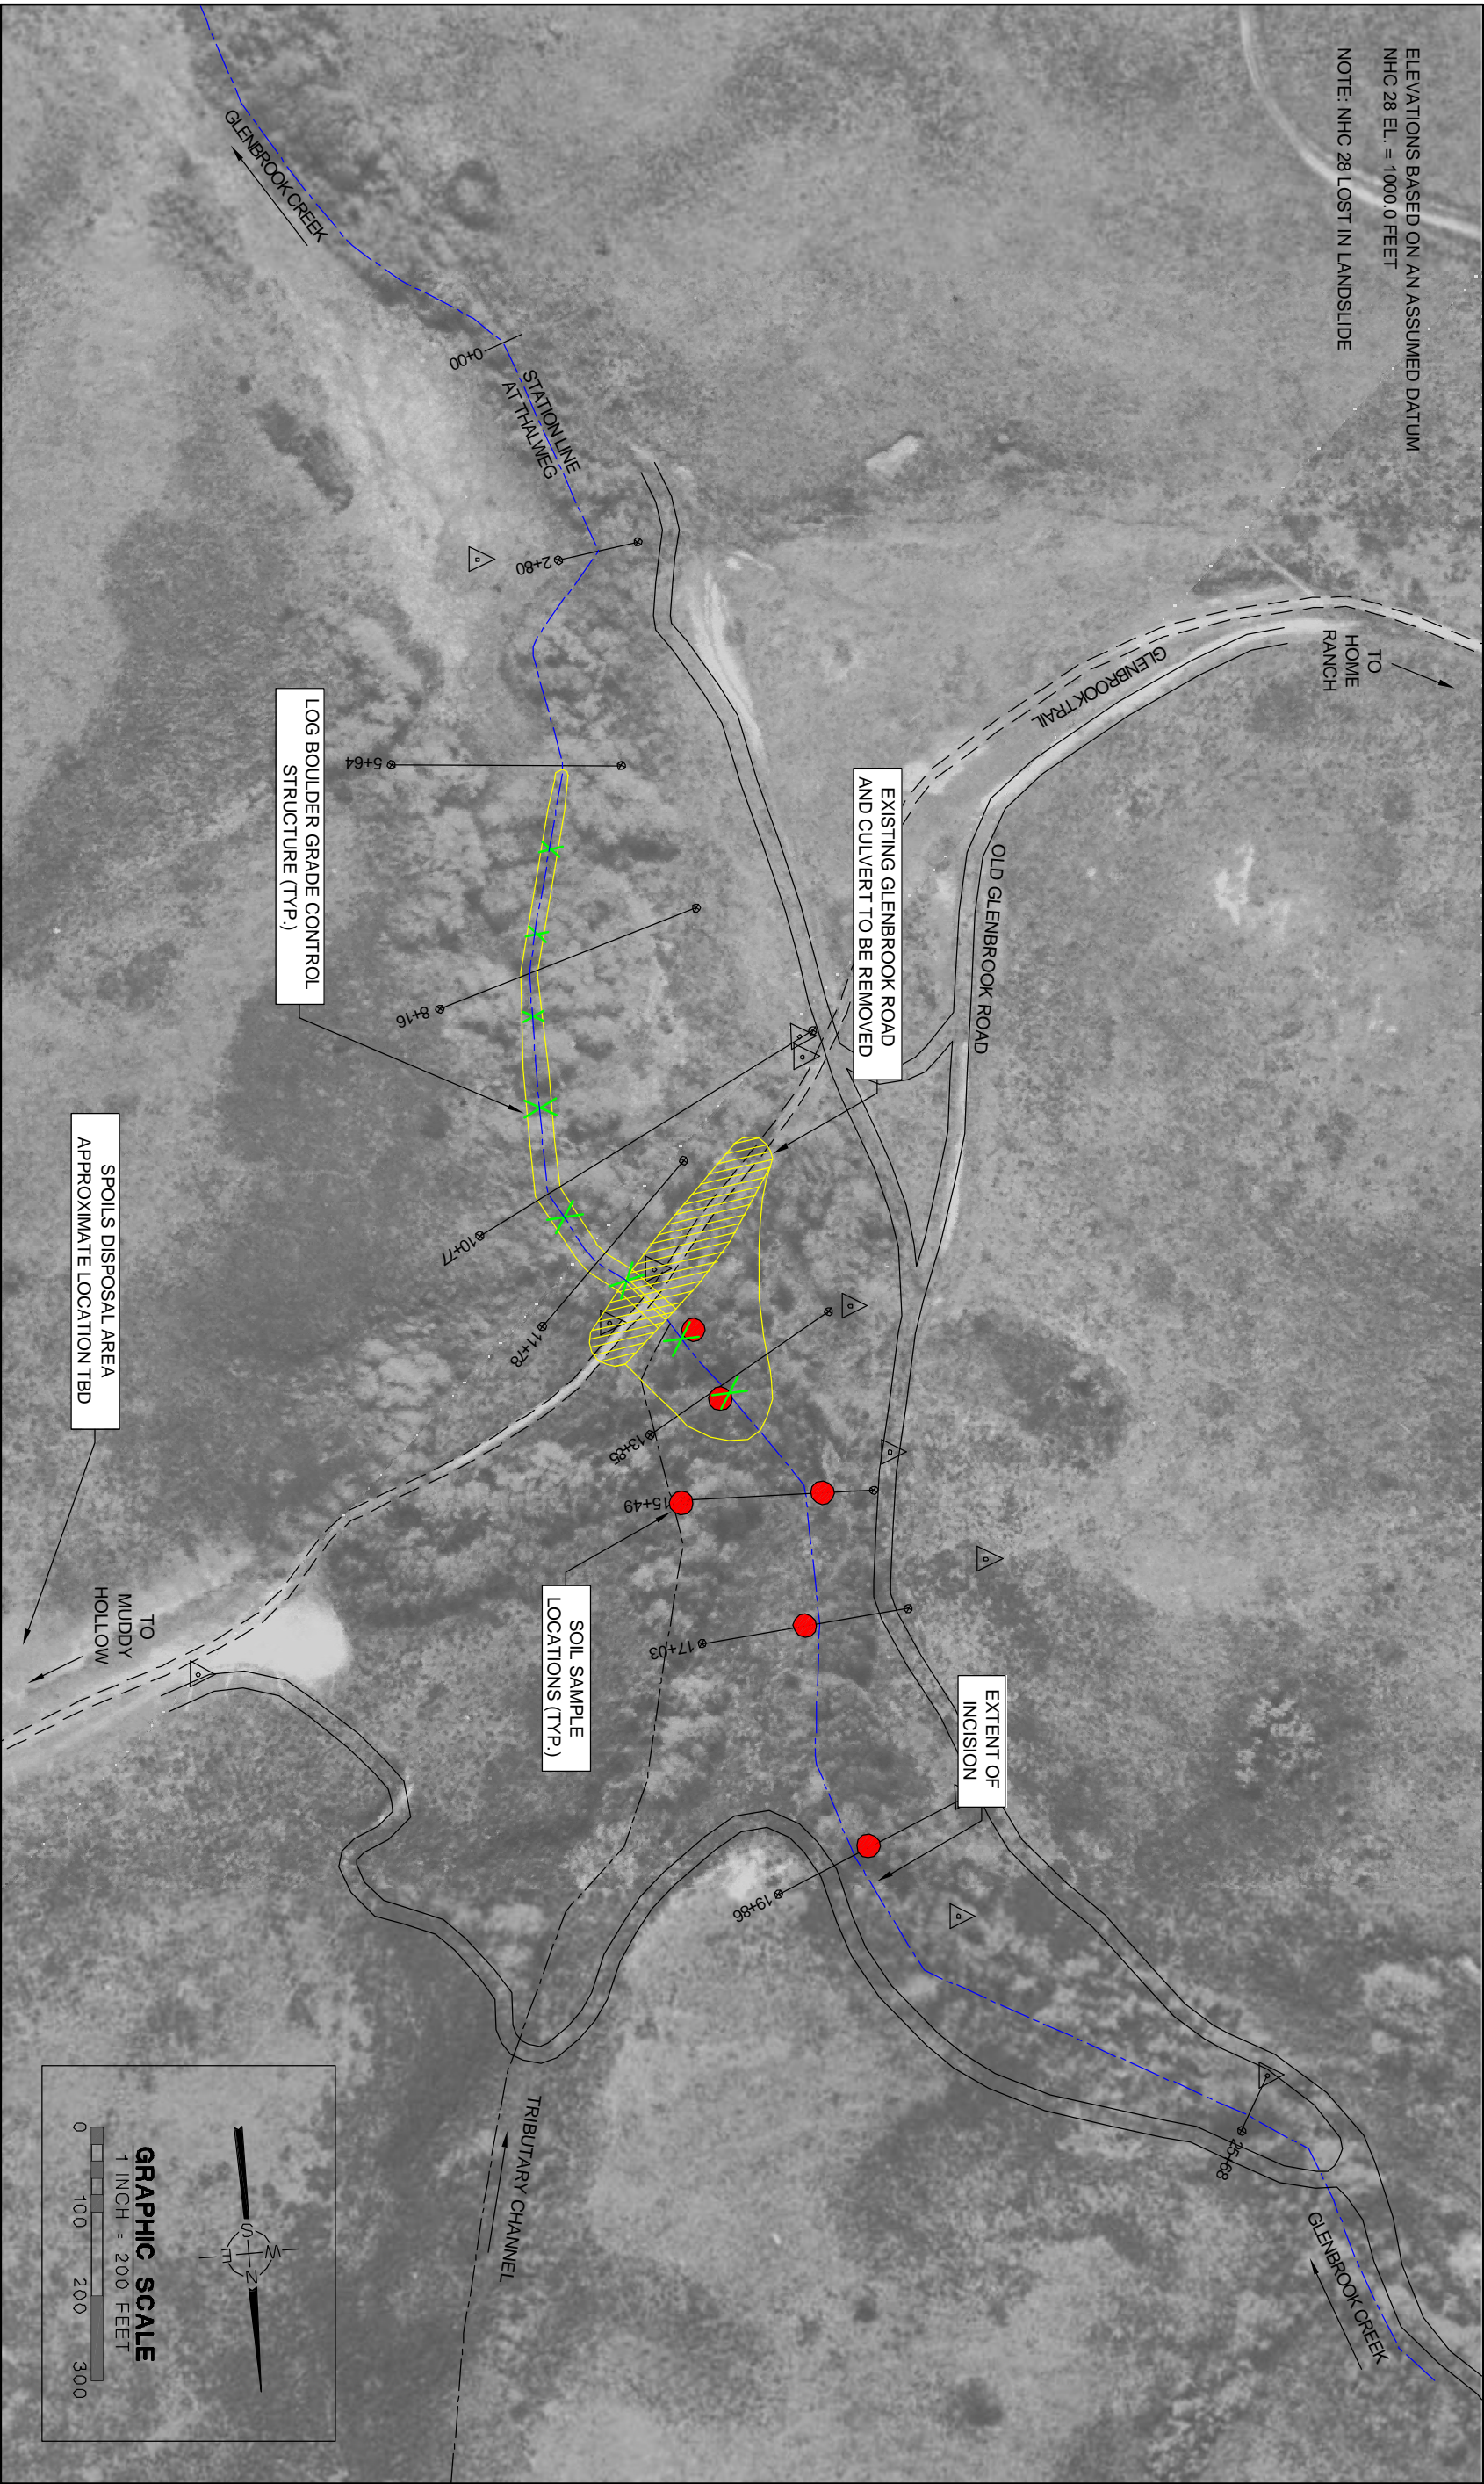
Figure 18. Alternative 2: Glenbrook Crossing Restoration Site Plan - Channel Development
